**RESEARCH INTO THE INFLUENCE OF MECHANICAL LOSSES
IN THE PLUNGER PAIR ON THE PERFORMANCE OF THE
HYDRAULIC DRIVE**

*Dmytro Motornyi Tavriya State Agrotechnological University, Zaporizhzhia,
Ukraine*

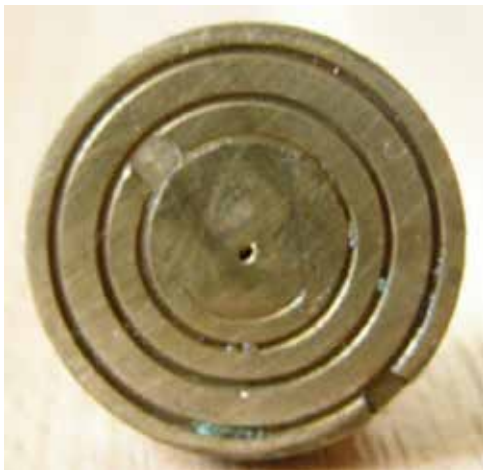
Common type of plunger heel wear

An increase in the temperature regime of the parts in the connections "annular heel support - cradle support" for an axial-piston hydraulic pump, and "annular heel support - inclined washer" for a hydraulic pump, ultimately leads to complete crushing of the annular heel support with subsequent rolling of its output channel, which ensures the supply of working fluid to the heel and the operation of the hydrostatic bearing as a whole (Fig. 3, 4).

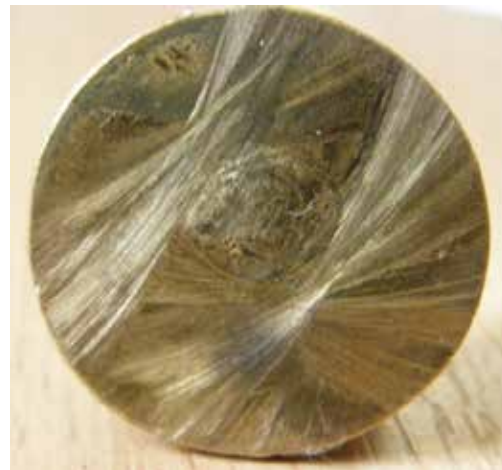
4. Complete wear of the heel ring support with rolling of the hydrostatic bearing hole

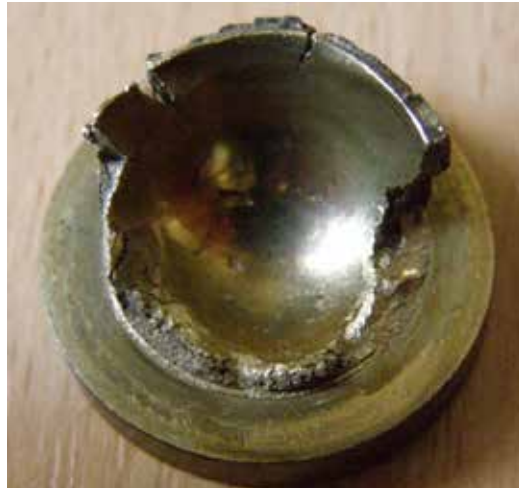
Fig. 5. Heel separation from the plunger bore

The increase in the overturning moment is the main reason that leads to the destruction of the plunger heel bearing (Fig. 5). The heel breaking out of the plunger bearing leads to a sudden emergency failure, because the direct contact of the spherical surface of the plunger with the inclined washer leads to the seizure of metals, which causes the jamming of the pumping unit of the axial-piston hydraulic machine.
